Midway City Council
20 September 2022
Work Meeting

The Village /
Underground Garages

CITY COUNCIL WORK MEETING STAFF REPORT

AGENDA ITEM: Below Grade Garages

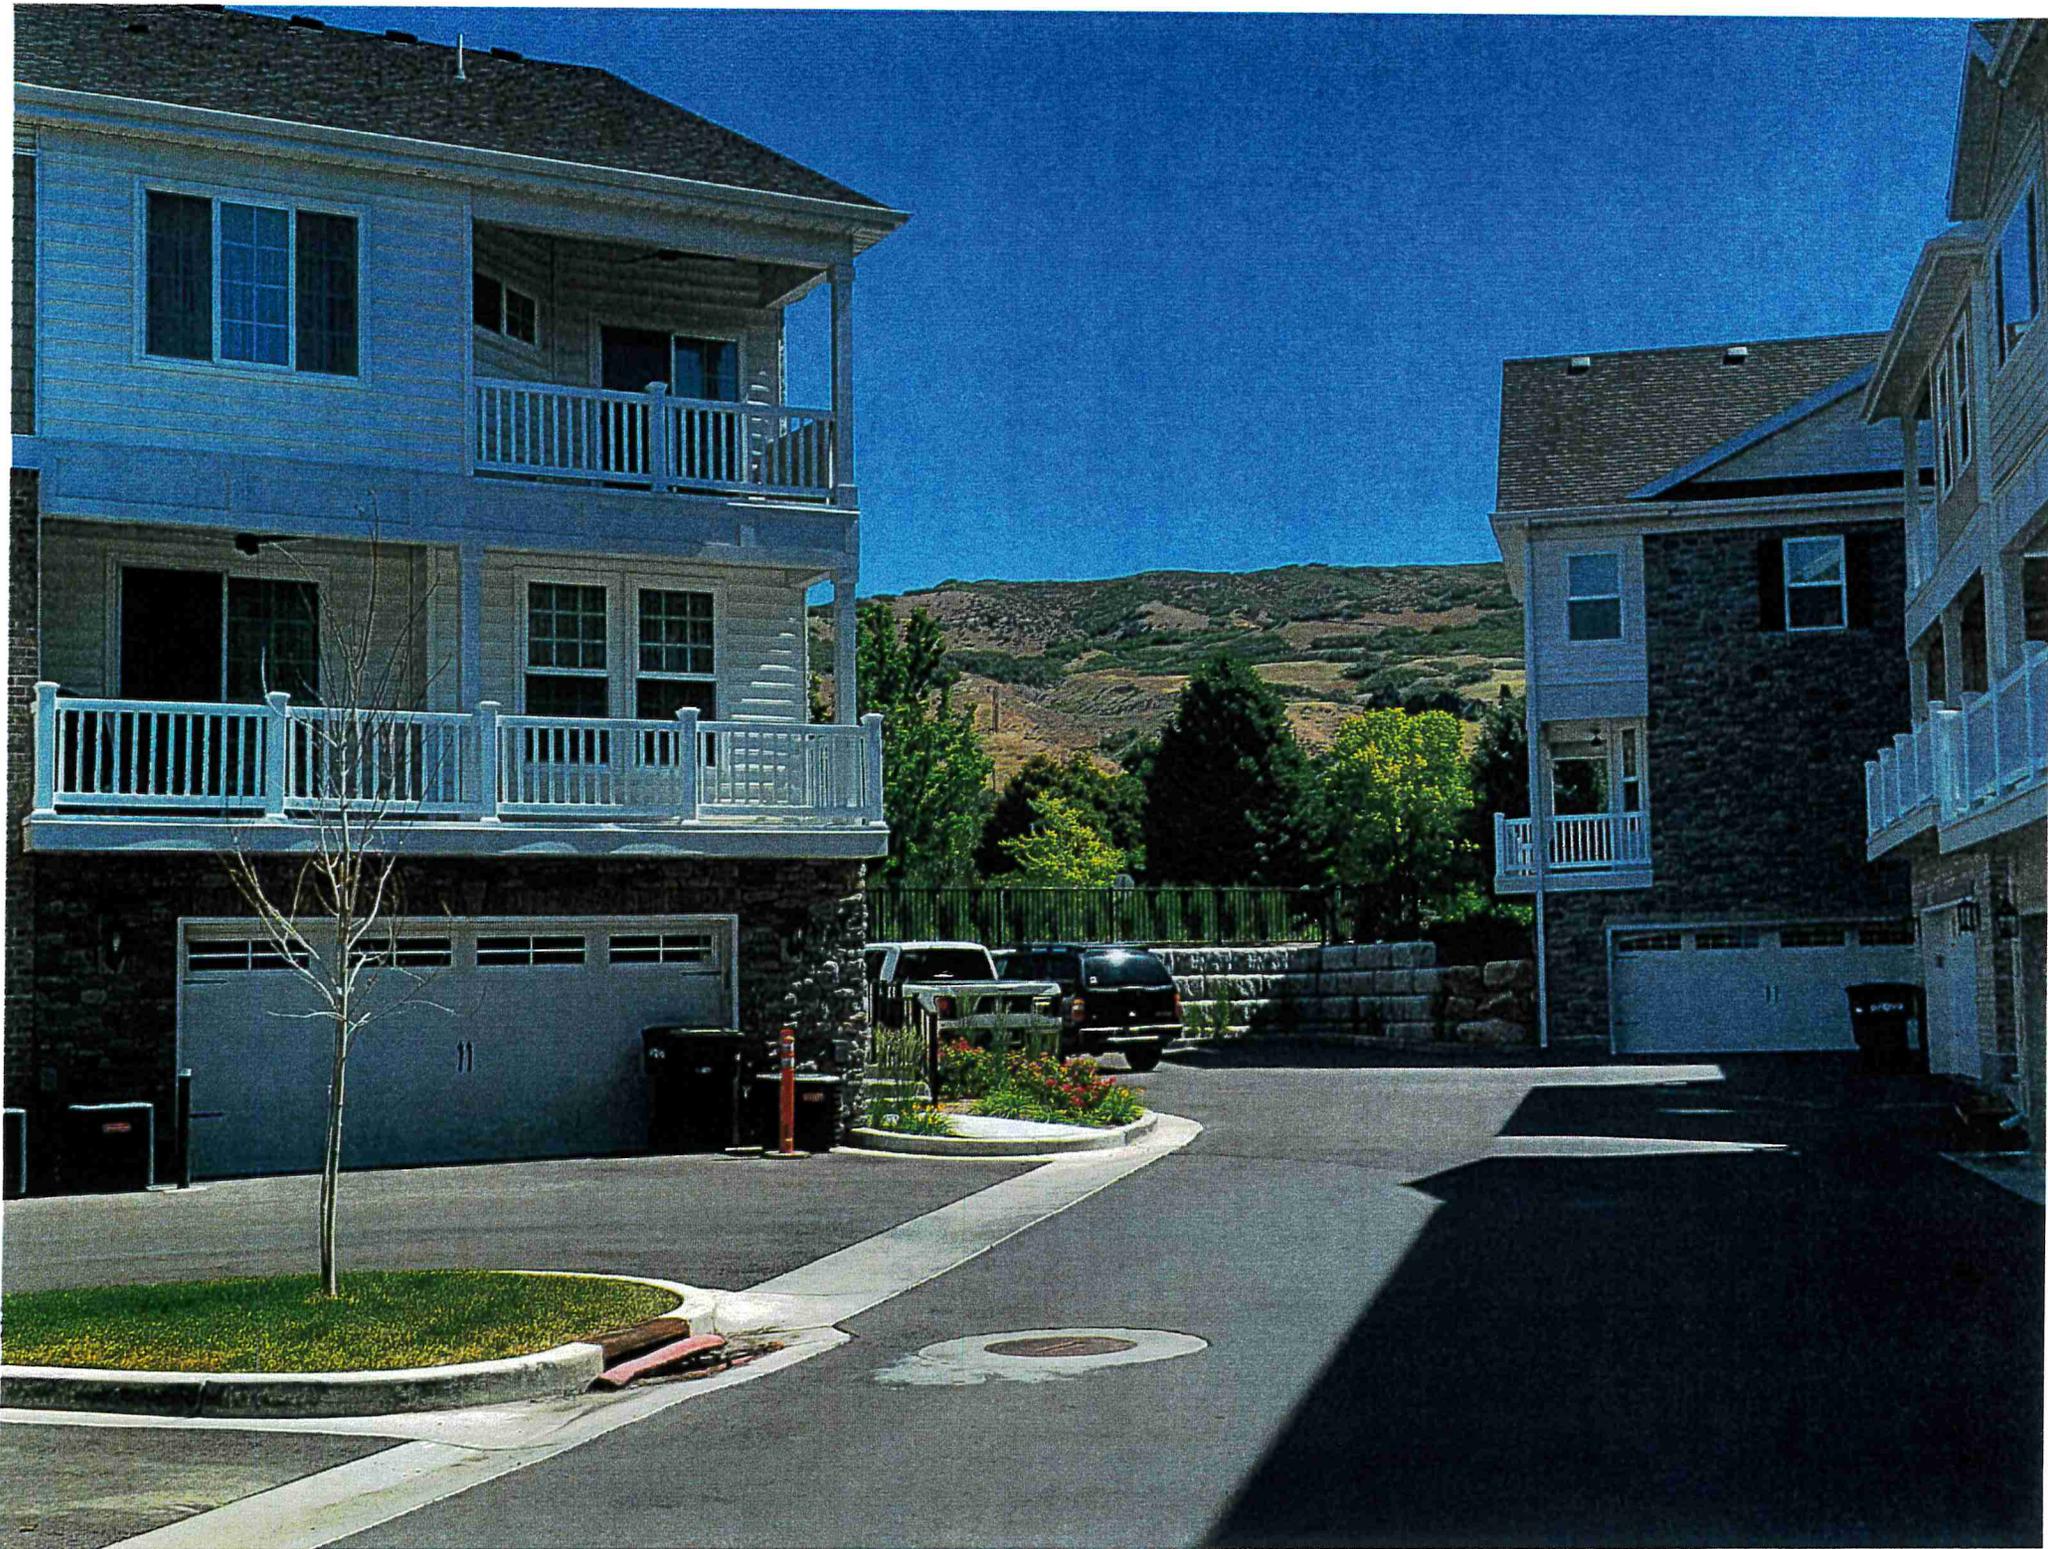
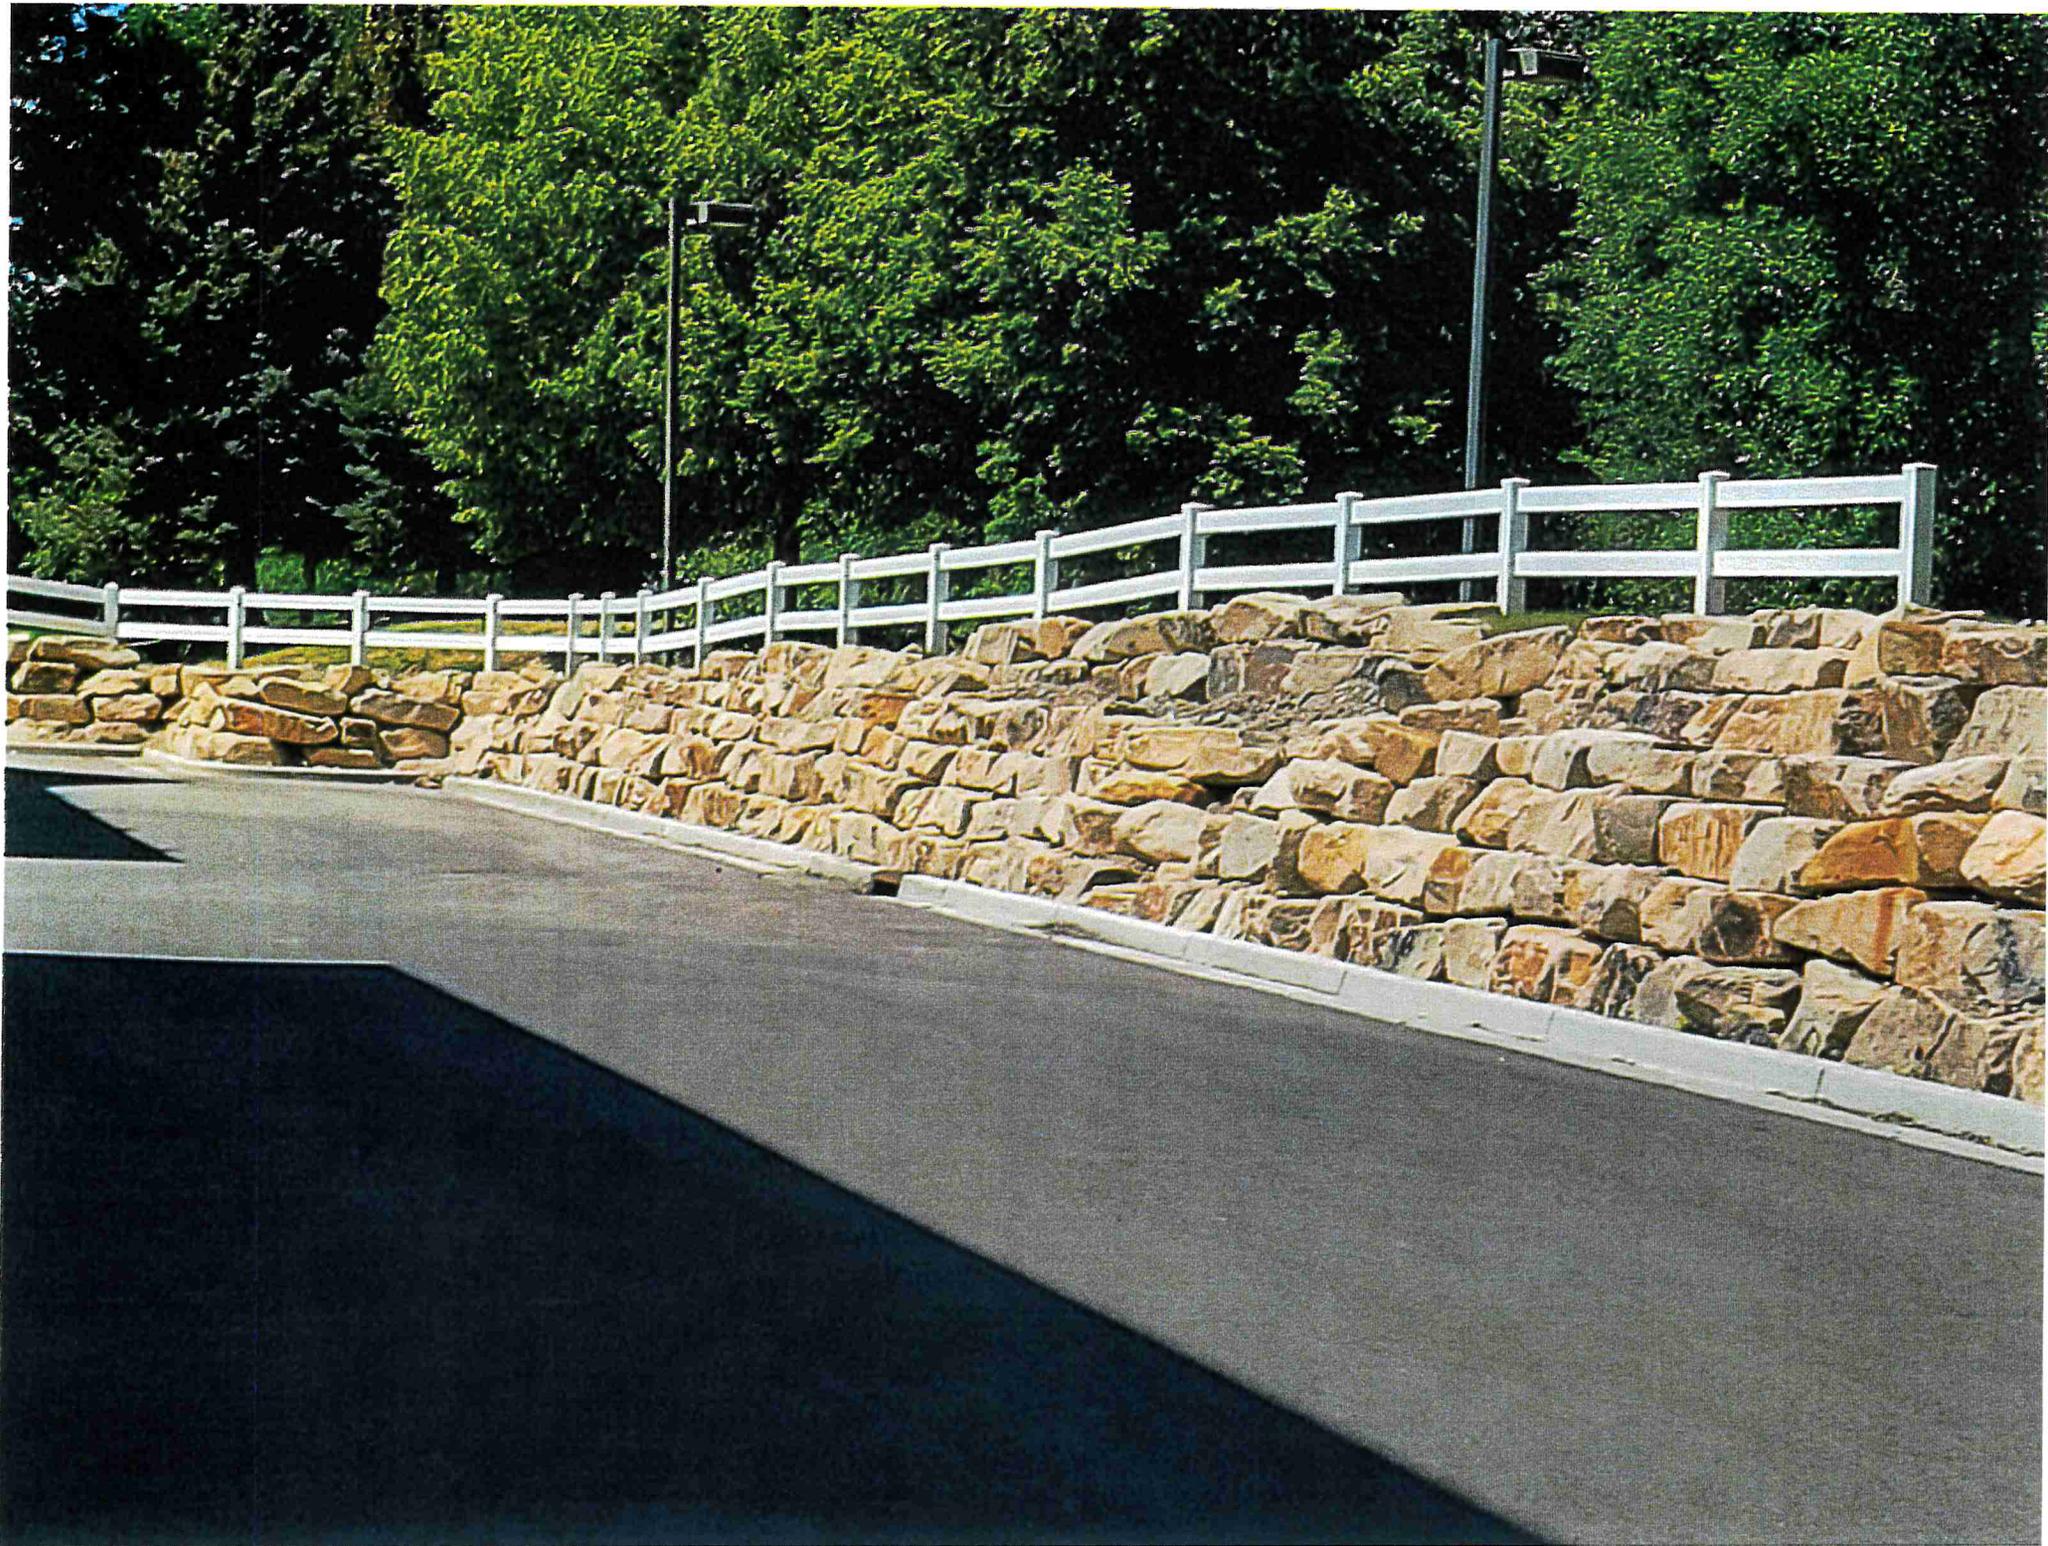
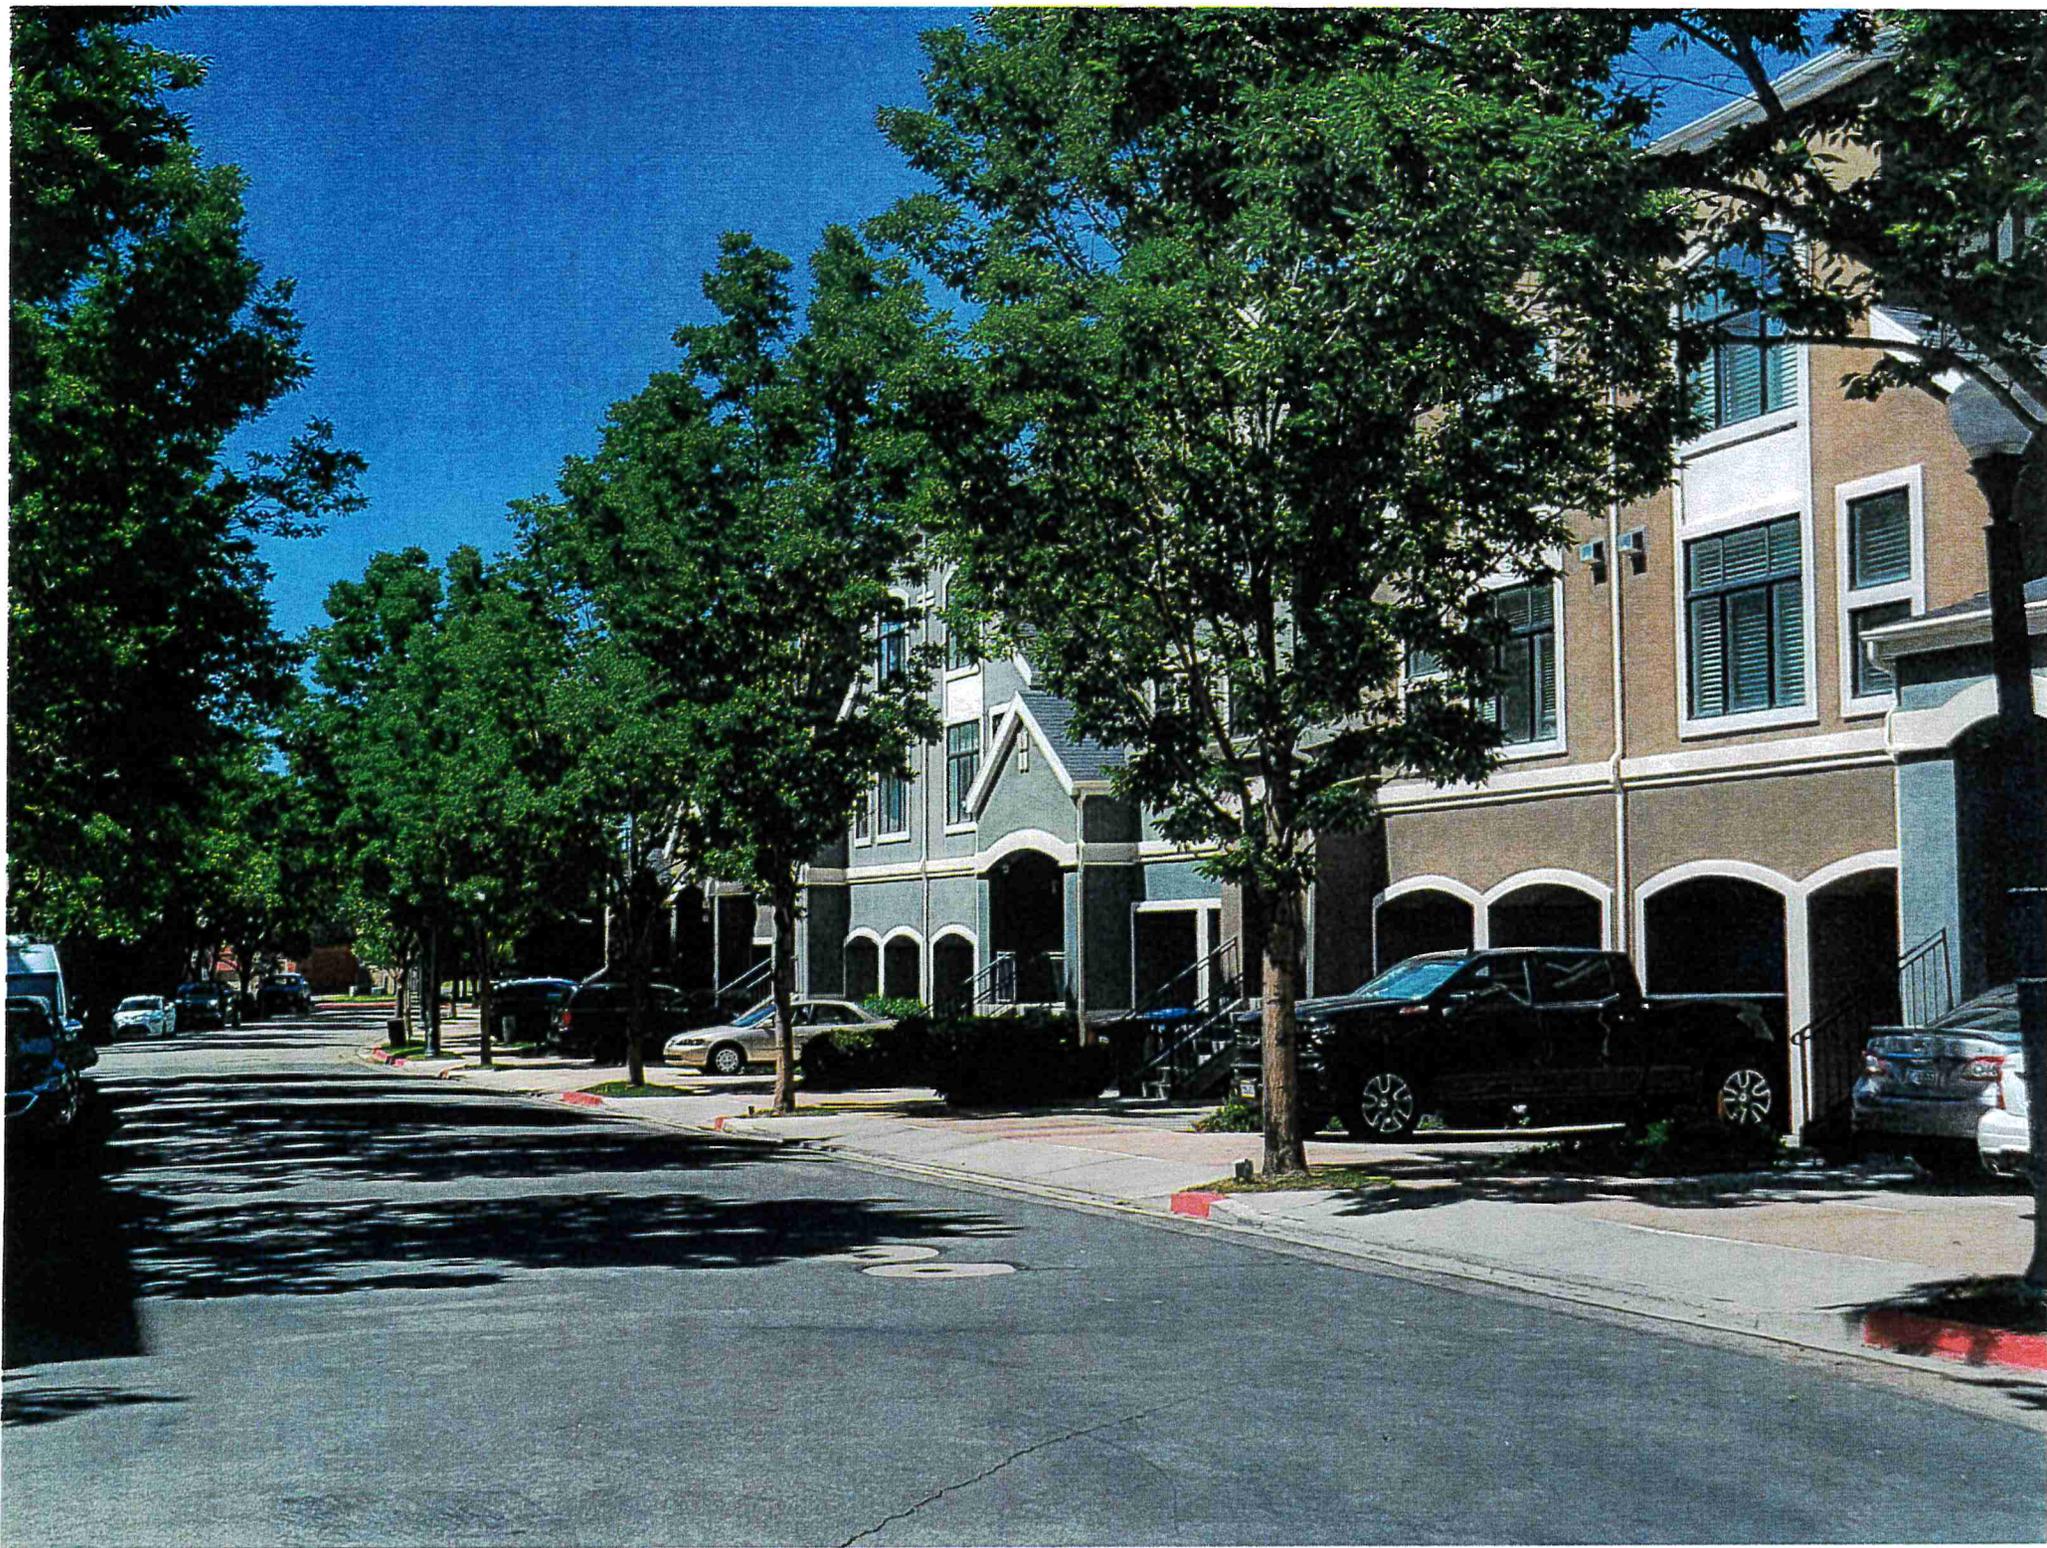
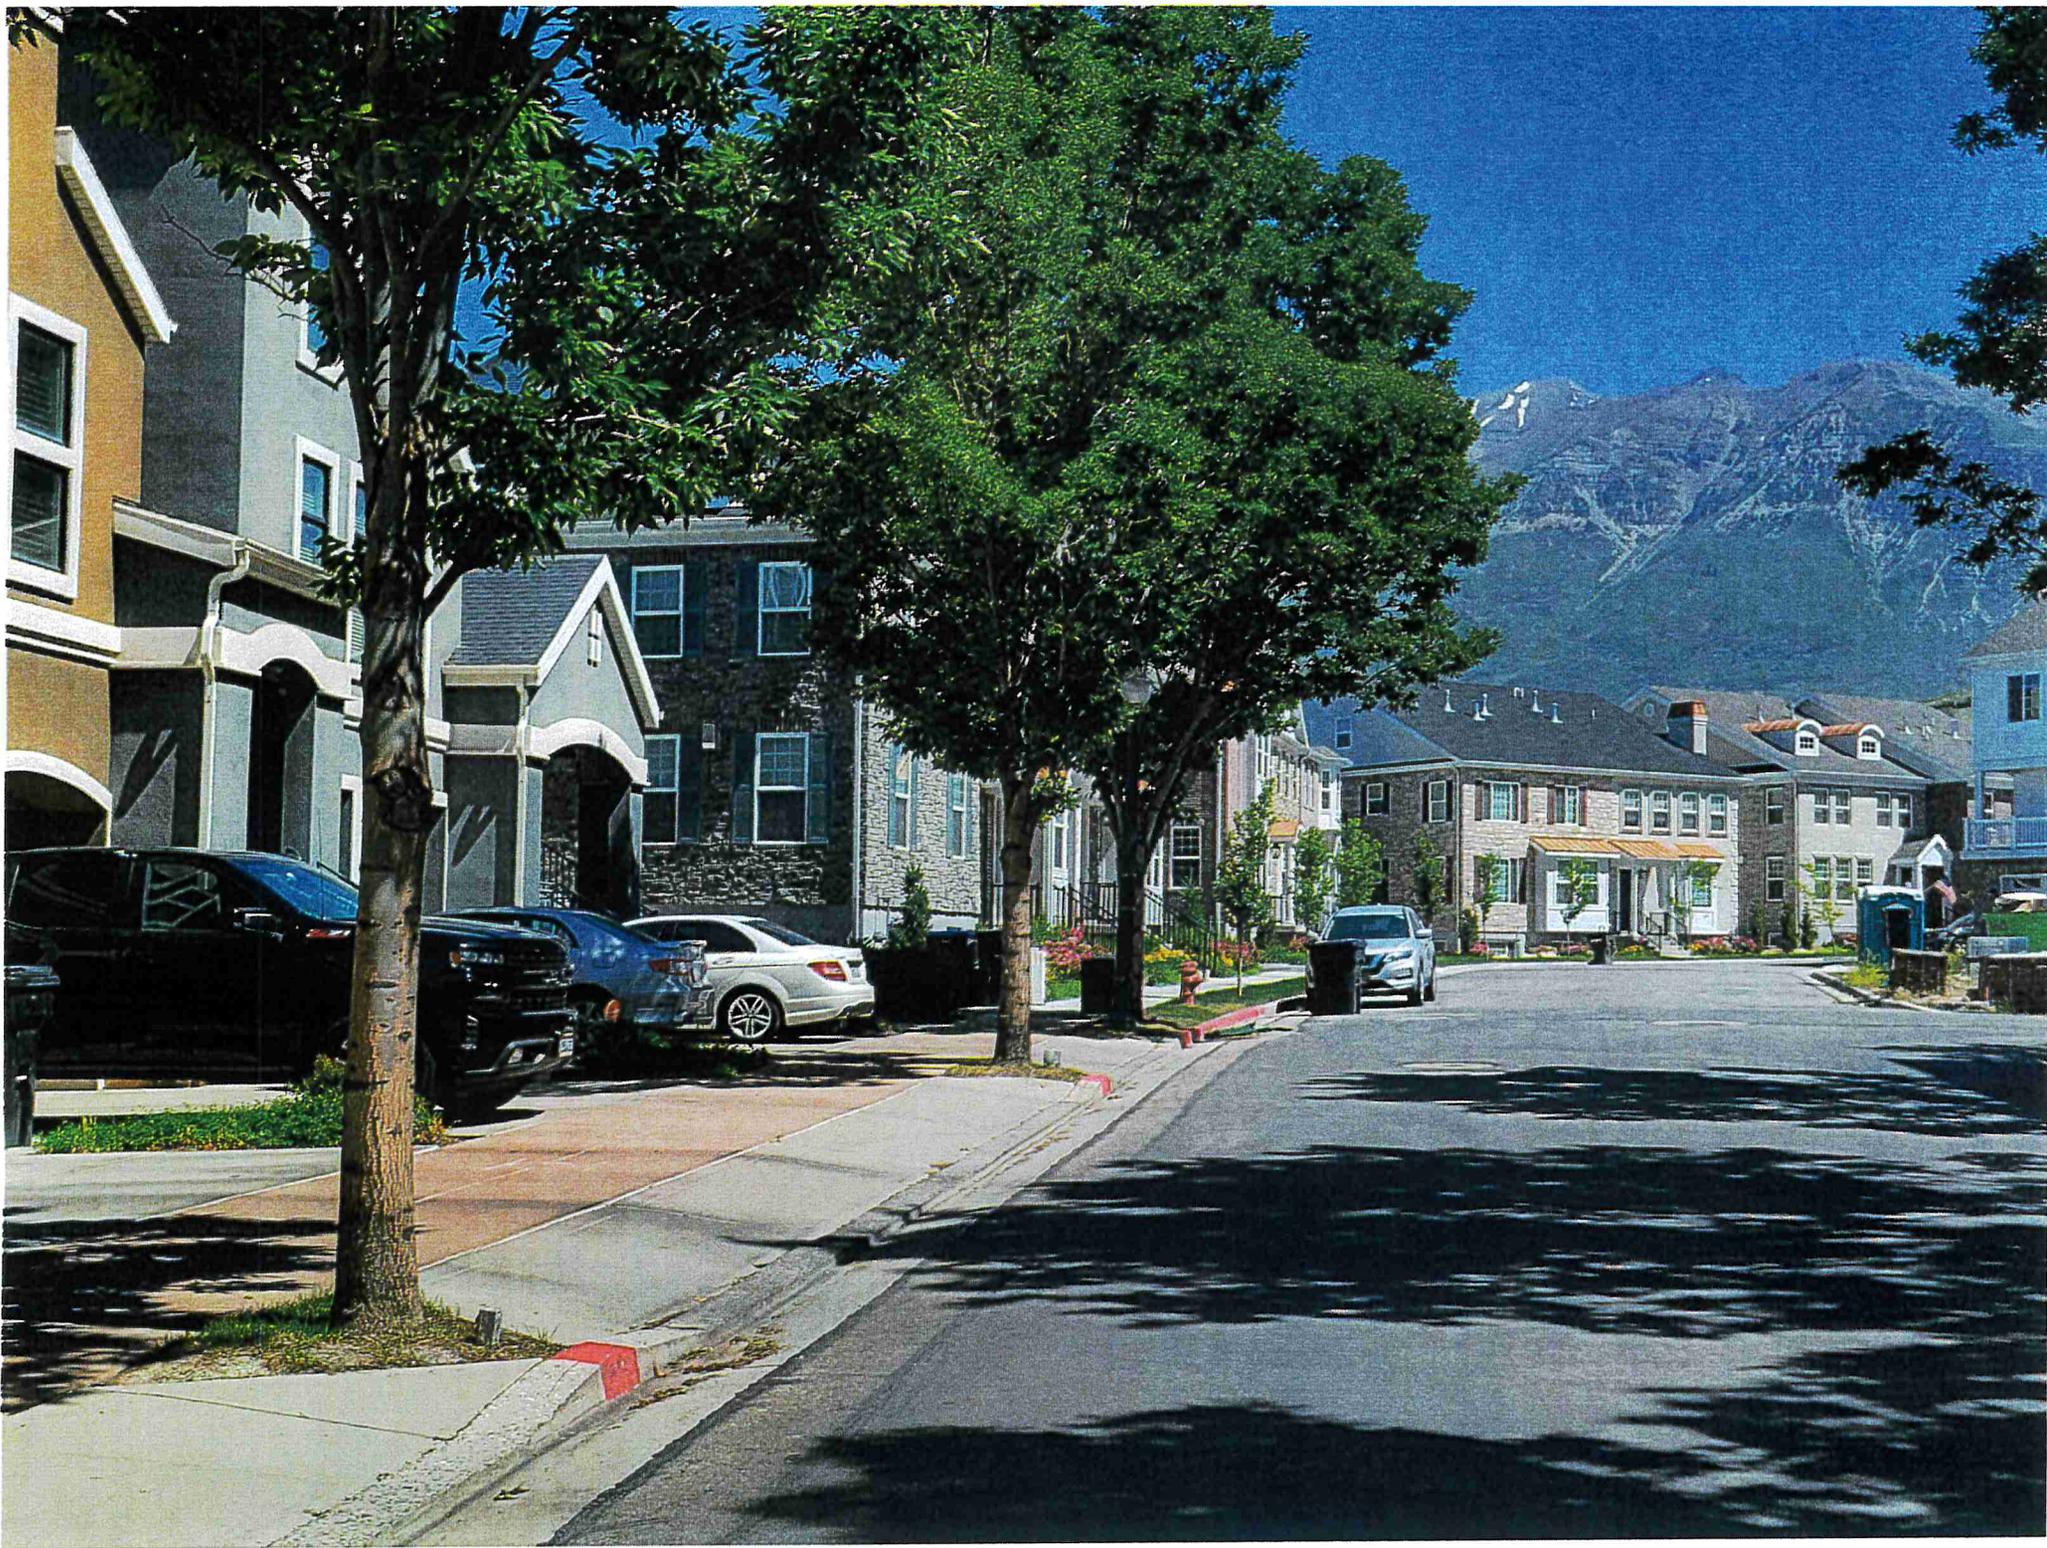
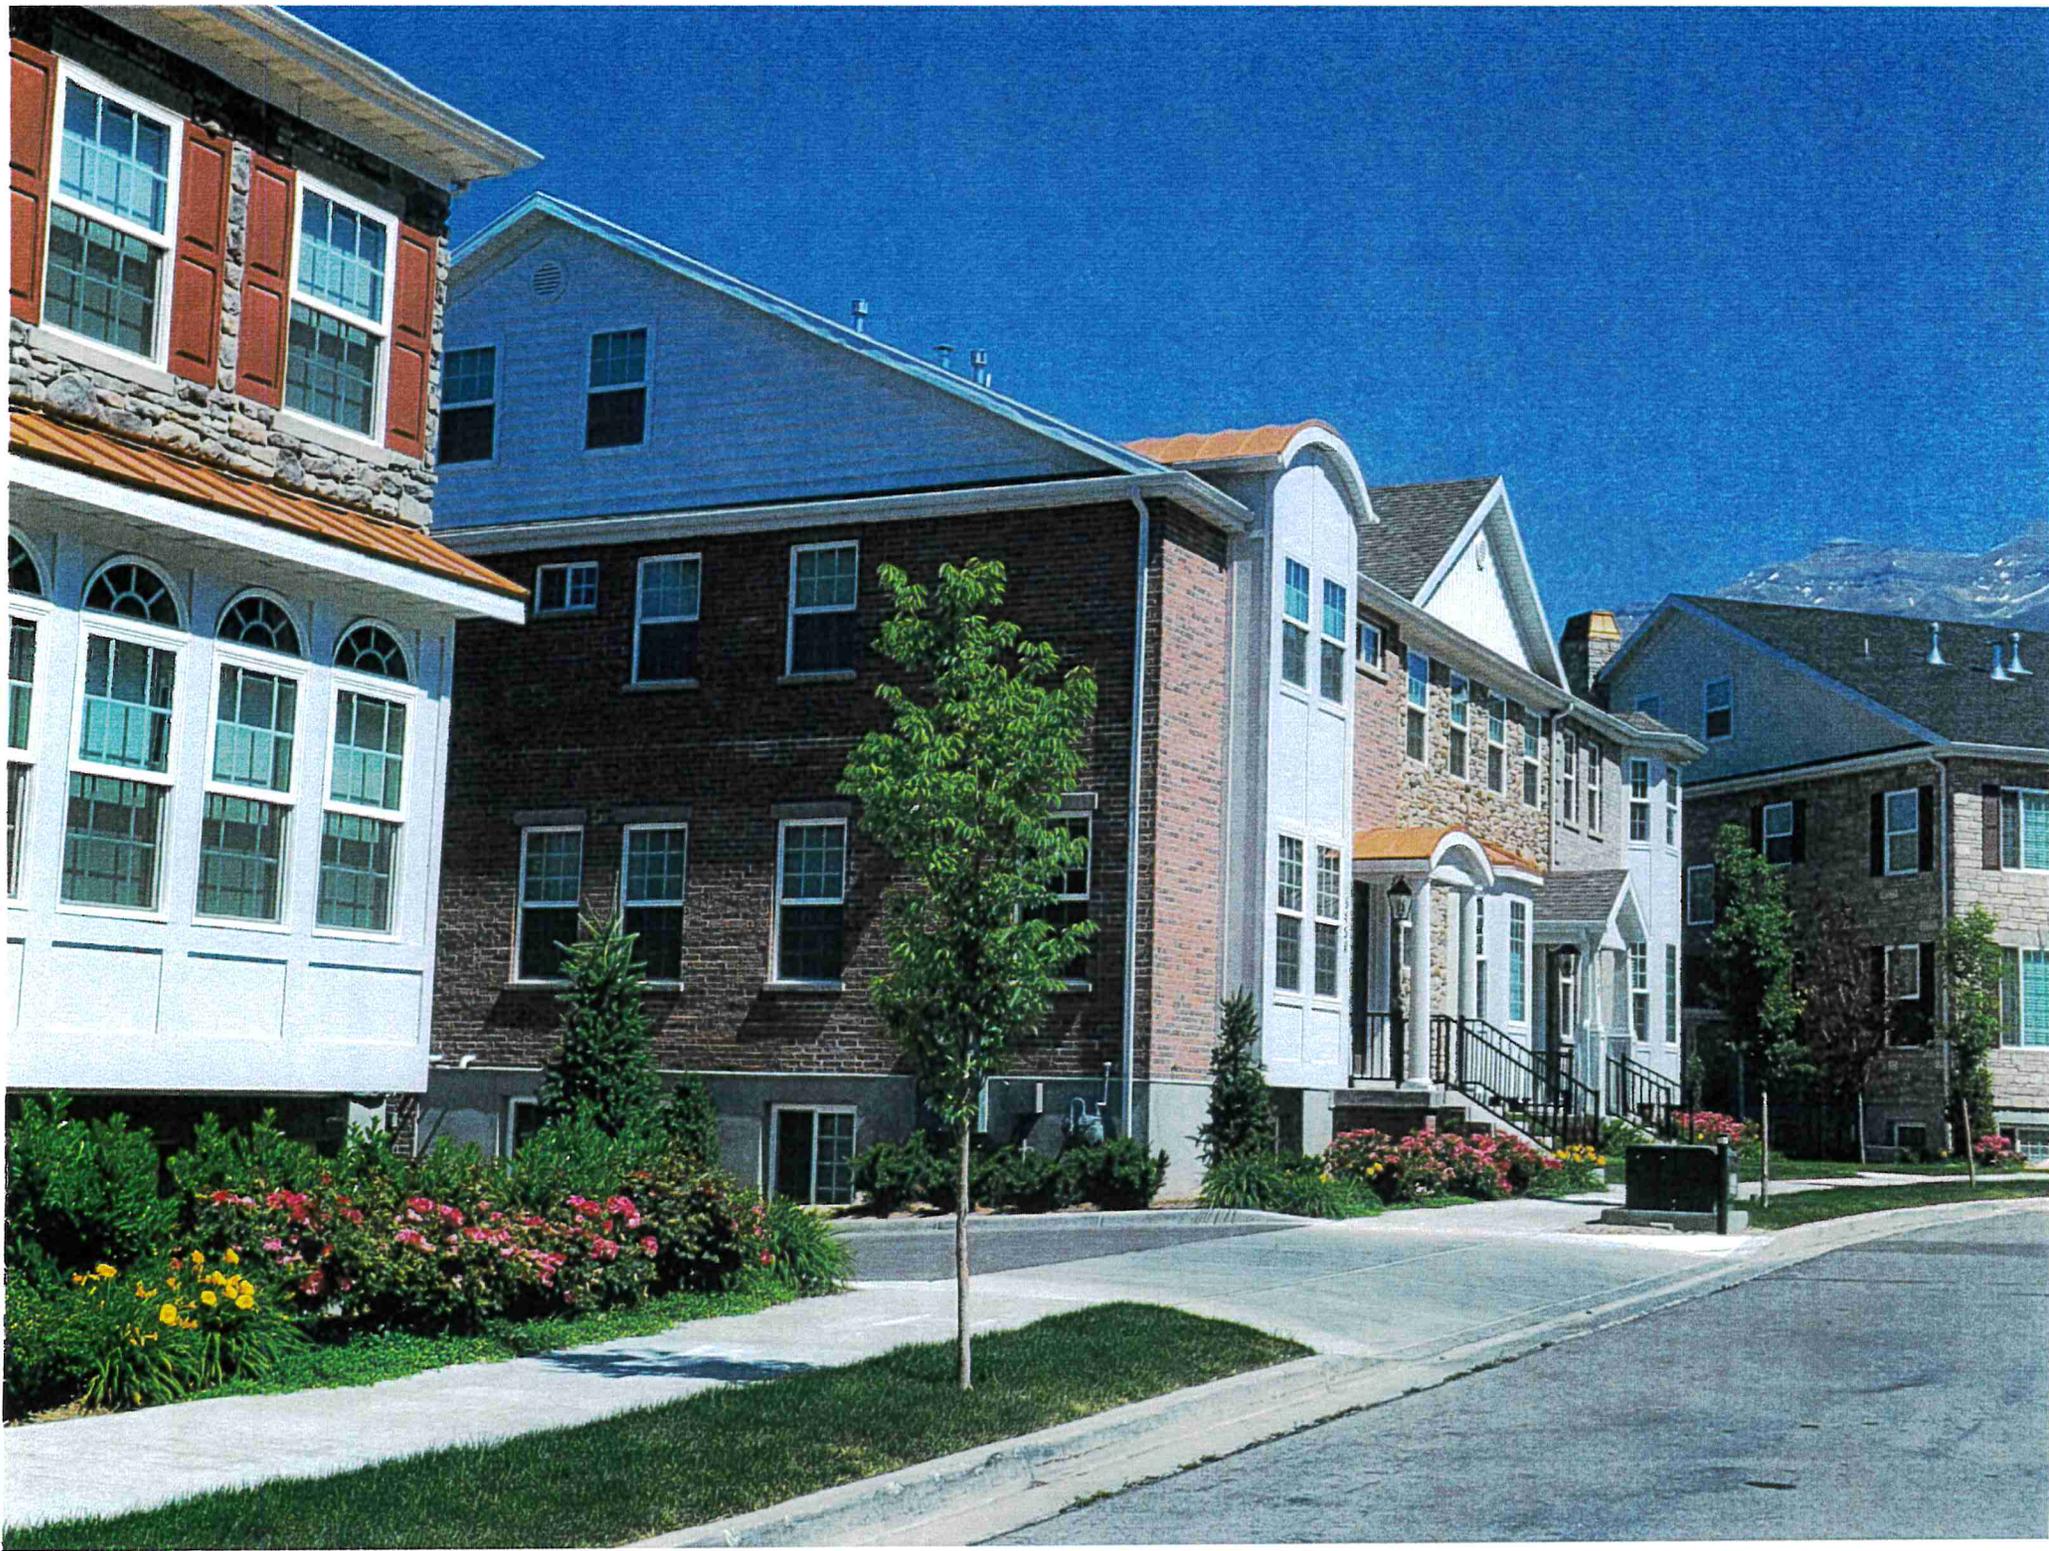
3. The retaining areas for the subgrade parking use landscaping rocks and fencing, very similar to the examples attached to this report, that are found at the Riverwoods in Provo.

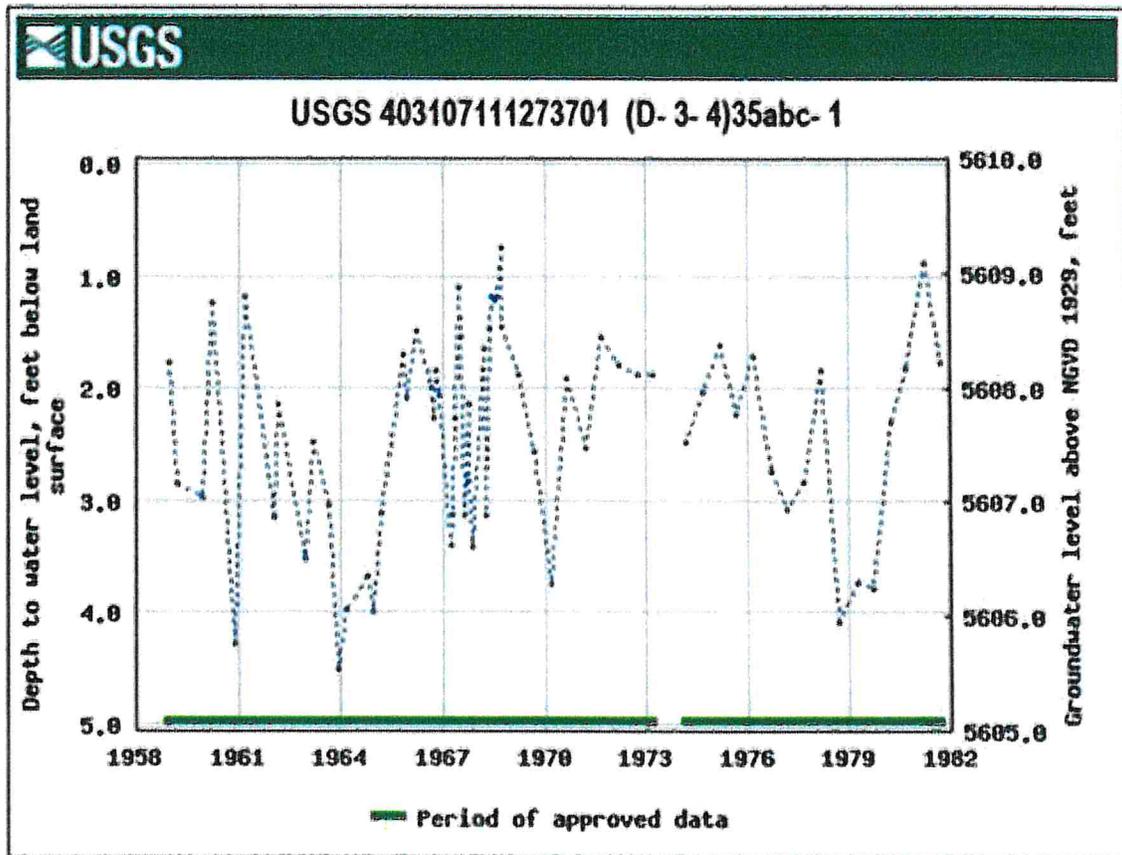
Reference: USGS National Water Information System, 2022

The U.S. Geological Survey (USGS) monitored the water level in Observation Well (D-3-4)35abc-1 (the USGS Observation Well) from the late 1950s until 1982. Figure 1 shows the location of the well. We were not able to find a well log in the Utah Division of Water Rights (DWRi) online database, but (1) the USGS indicates that the well is completed to a depth of 21 feet and (2) based on its location and depth the well is likely completed in tufa. Water levels in this well appear to be representative of the shallow groundwater system in the Northwest Quarter of Section 35. The following is a plot of groundwater level versus time (hydrograph) in the well between 1959 and 1982. This plot indicates that shallow groundwater was consistently present and that the level fluctuated seasonally by about 1 to 3 feet. The USGS has not monitored this well since 1982.

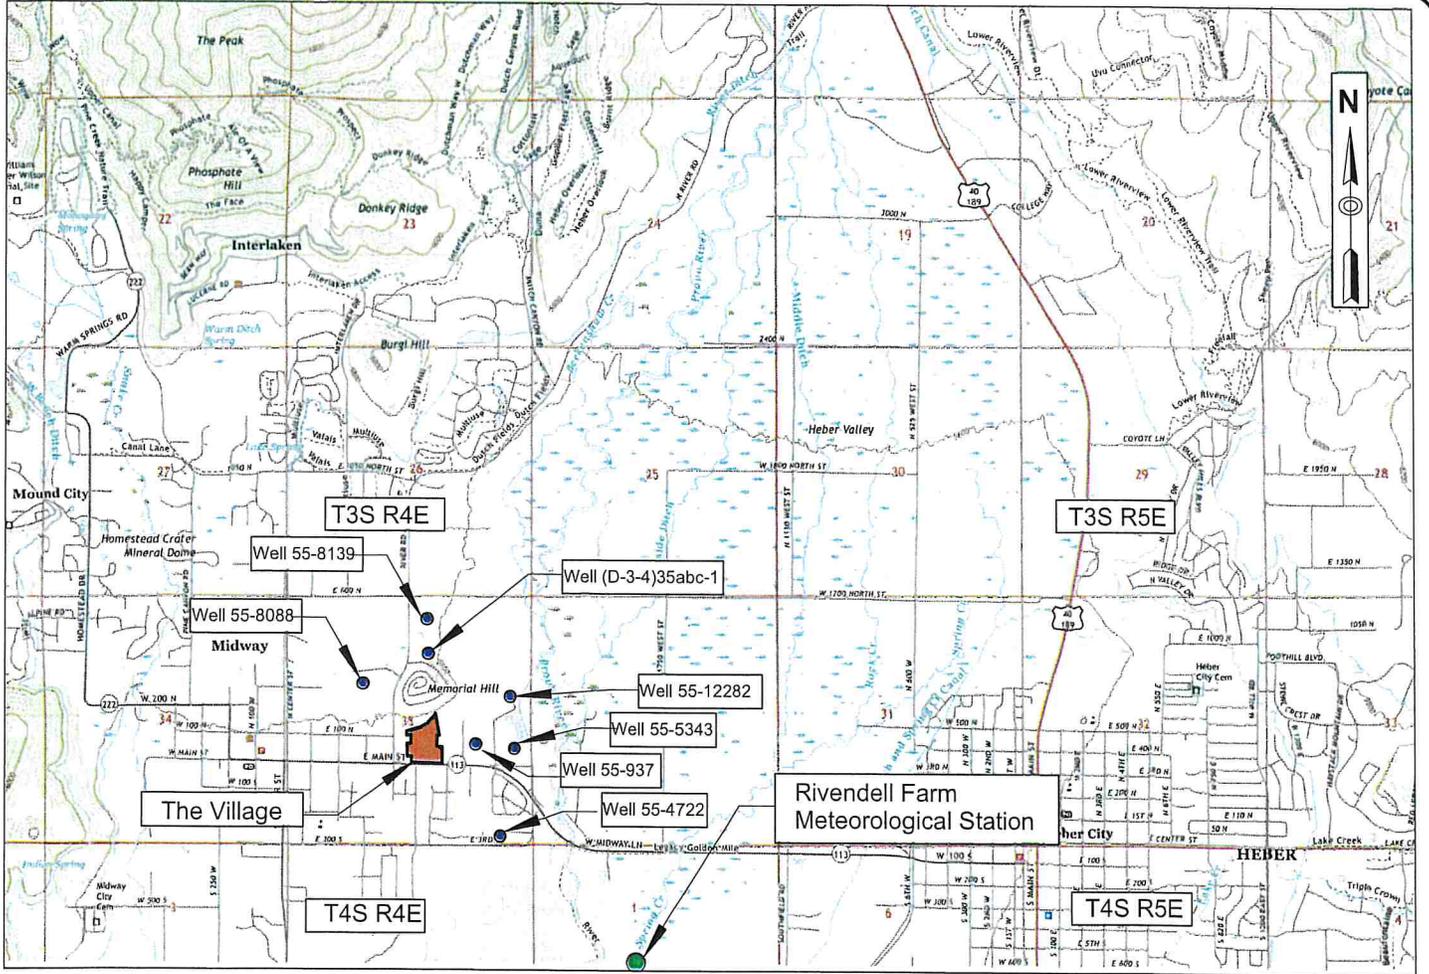
Horrocks Engineers
 The Village
 Location Map
 Figure 1

Scale Topographic Map - Heber, Utah, 2020

All locations are approximate

Midway is reviewing The Village, which as shown on Figure 1, lies south of Memorial Hill, east of River Road, and north of Main Street. The Village:

During the 3-month period from August 1, 2017, to October 31, 2017, The Village area received only 2.18 inches of rainfall; see Attachment 2. Rainfall is measured and recorded at Rivendell Farm, a meteorological station at the approximate location shown on Figure 1. During the 10-day period (October 16 to October 27, 2017), between drilling and the apparent observation of groundwater in Borings B-2 and B-4, the area received only 0.01 inches of rain. CMT (2017a) did not report whether the slotted pipes placed in Borings B-1, B-2 and B-4 were gravel packed or sealed from the ground surface. If the slotted pipes were not gravel packed and sealed, surface water from flood and forced irrigation at The Village property could have saturated the thin silty loam layer that overlies the tufa and flowed into the borings. Attachment 3 indicates that the silty loam material has a low permeability of about 0.06 inches per hour.

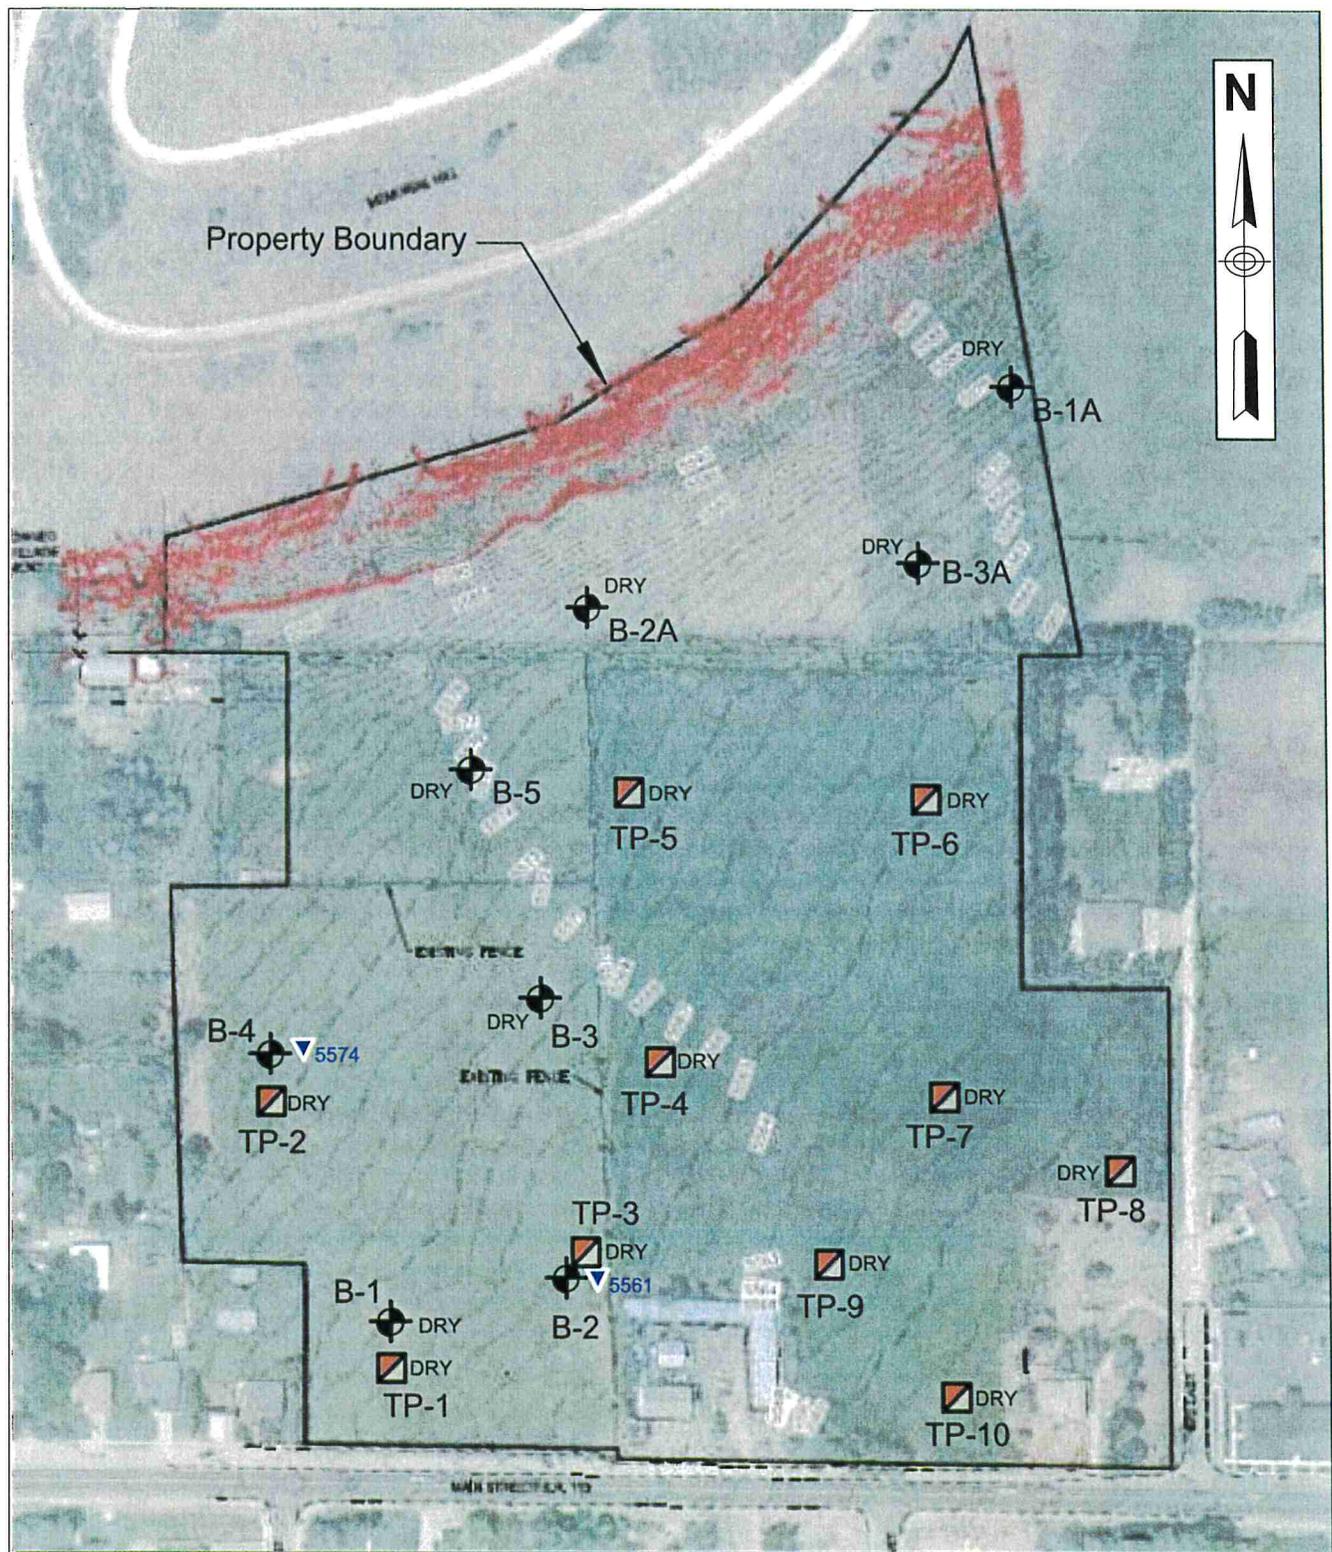
Reference: Berg Engineering - Sensitive Lands Map, Sheet 2, May 25, 2022

The Village
Location of CMT Test Pits,
Borings and Site Features

CMT (2017a, 2017b, and 2021a) performed multiple geotechnical investigations during 2017 and 2021. Figure 2 shows the locations of borings and test pits completed by CMT from 2017 to 2021. Except for borings B-1A, B-2A, and B-3A, CMT test pits and borings intercepted thin soils overlying tufa deposits.

- Conducted a second geotechnical investigation for Beaugency Development (CMT, 2017b) to the north of the initial investigation in which they (1) drilled and logged three borings to 16.5 feet through clays (see Figure 2 for locations), (2) did not encounter groundwater, and (3) presented their findings in a report dated December 20, 2017.

- Conducted a third geotechnical investigation during 2021 (CMT, 2021a), this time for The Village, in which they:
 - Excavated and logged 10 test pits to a depth of about 10 feet below ground surface, two of which were excavated adjacent to Borings B-2 and B-4 and were dry (see Figure 2 for locations);

See Figure 2 for locations of borings and test pits.

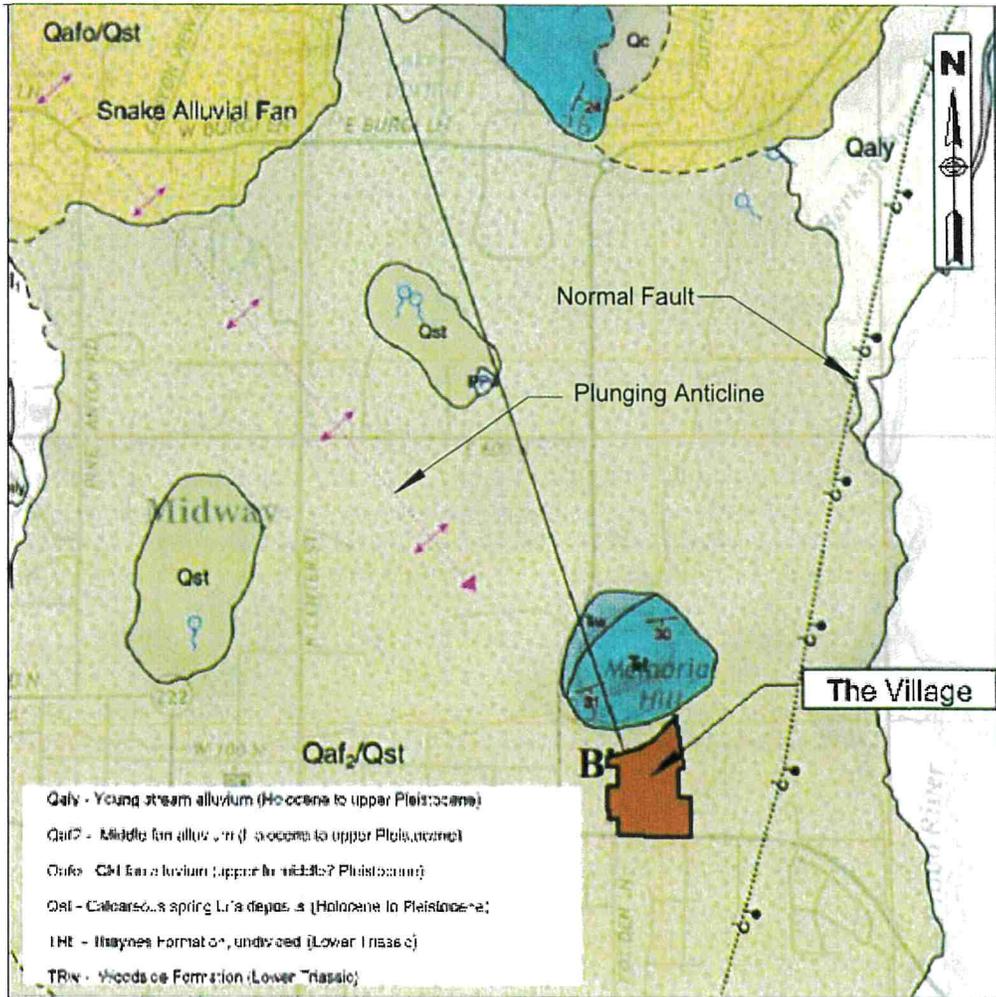
Horrocks Engineers
The Village
Geologic Map
Figure 3

Reference: Biek, 2019

Midway is in the western part of Heber Valley. Figure 3 is modified from Biek (2019) to show the surficial geology of The Village and Midway areas. Unconsolidated deposits near The Village include eastward-sloping alluvial fans of Quaternary-age unconsolidated sediments that include poorly to moderately sorted, weakly to non-stratified, clay-to boulder-sized sediment shed from the Wasatch Mountains. These sediments were deposited principally by debris flows and debris floods at the mouths of active drainages such as Snake Creek and form alluvial fans (Biek, 2019). Well logs indicate the unconsolidated valley-fill deposits primarily consist of lenticular and discontinuous beds of poorly sorted material ranging in size from clay to boulders. In Midway, these unconsolidated deposits are interlayered with tufa (hot spring) deposits.

Figure 3 shows that the inferred anticline plunges (dives) to the southeast, towards, but ends north of Memorial Hill before reaching The Village. The tufa deposits are locally more than 100 feet thick and are underlain by alluvium (Kohler, 1979). The thickness of unconsolidated deposits overlying bedrock is confirmed in some of the well logs in Attachment 1. Tufa deposits crop out or interfinger with unconsolidated valley-fill deposits at shallow depths in the vicinity of Midway (Roark and others, 1991).
