Midway City Council
20 September 2022
Work Meeting

The Village /
Underground Garages

CITY COUNCIL WORK MEETING STAFF REPORT

AGENDA ITEM: Below Grade Garages

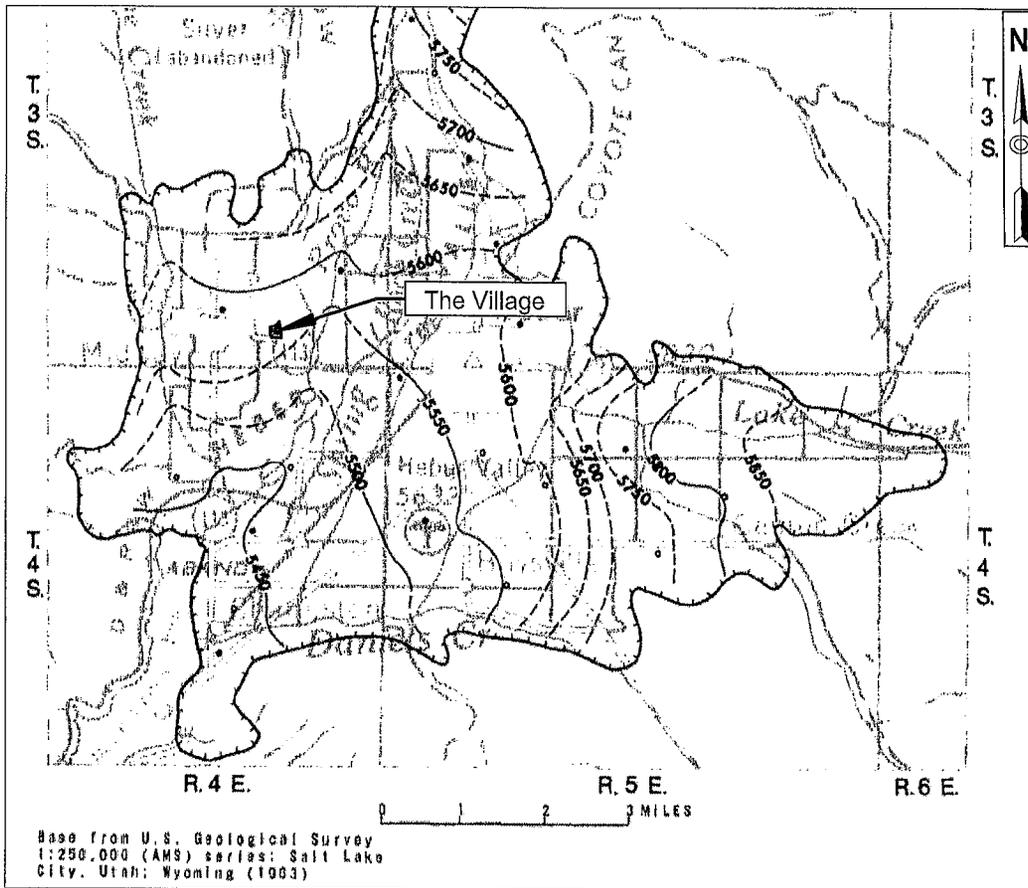
Figure 3

Reference: Baker, 1970, Figure 10

Horrocks Engineers
 Heber Valley
 Groundwater Elevation Map

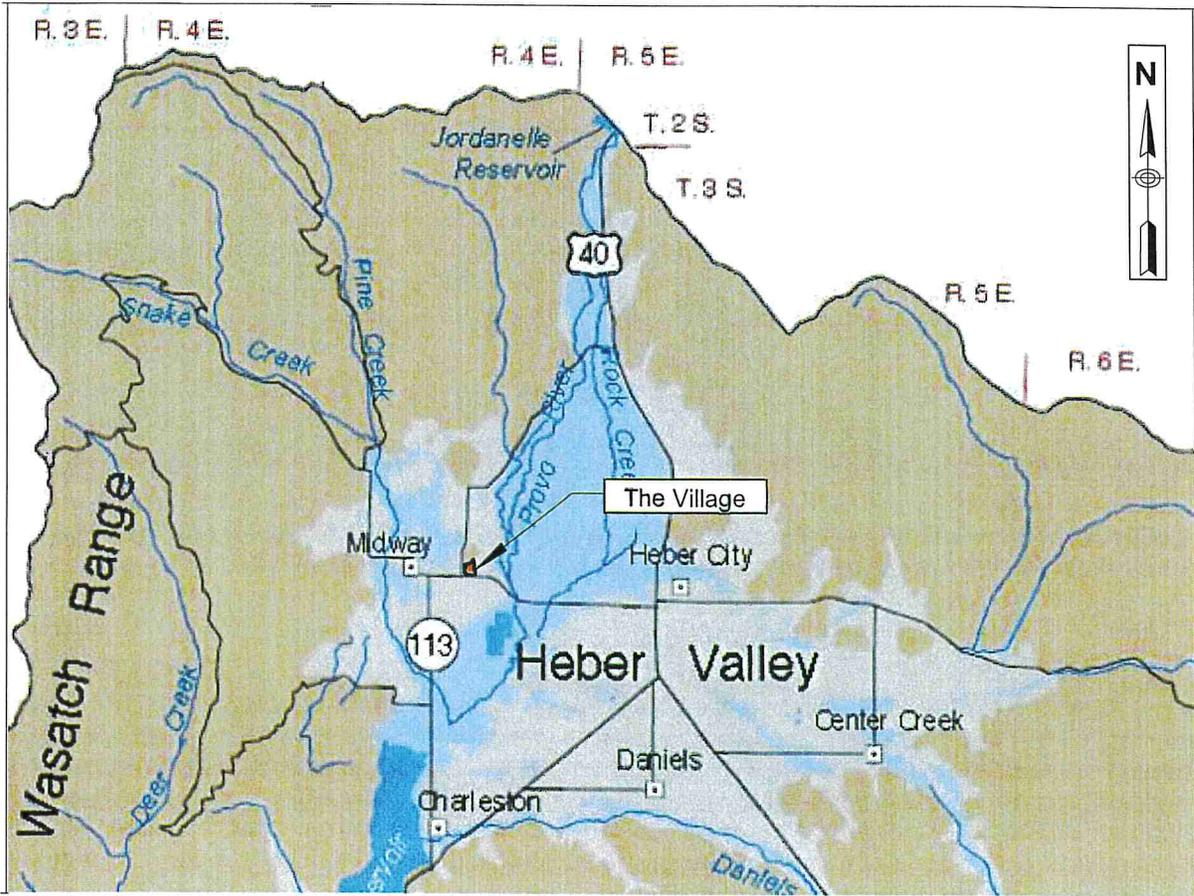
Reference: Ground-Water Sensitivity And Vulnerability To Pesticides,
 Heber And Round Valleys, Wasatch County, Utah, Lowe and Butler, 2003

Horrocks Engineers
 Shallow Groundwater in
 Heber Valley

Figure 5 shows the location of The Village and areas in Midway where groundwater is found at depths of 3 feet or less including:

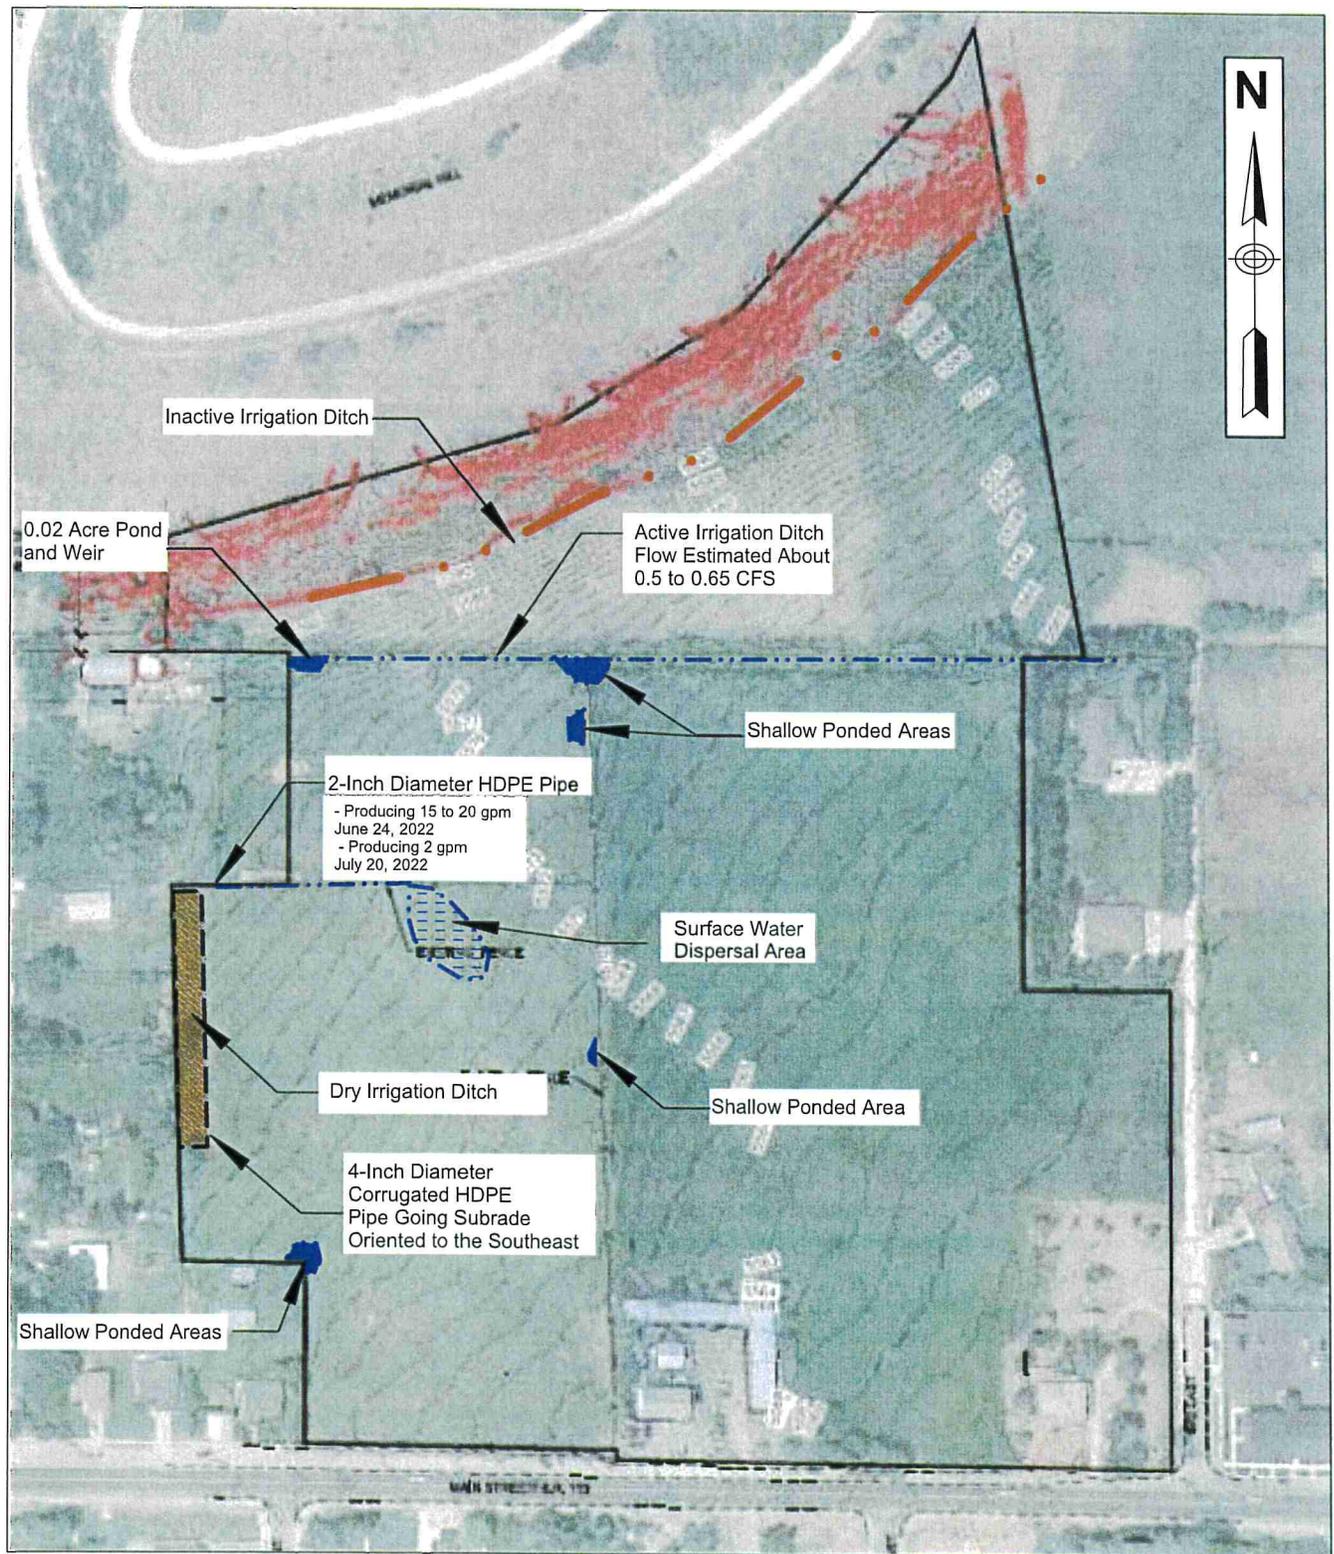
Reference: Berg Engineering - Sensitive Lands Map, Sheet 2, May 25, 2022

Loughlin Water observations on June 24 and July 20, 2022
